Illahee Marine Survey Tire Reef Cleanup Phase 1

07 December 2023

PORT OF ILLAHEE

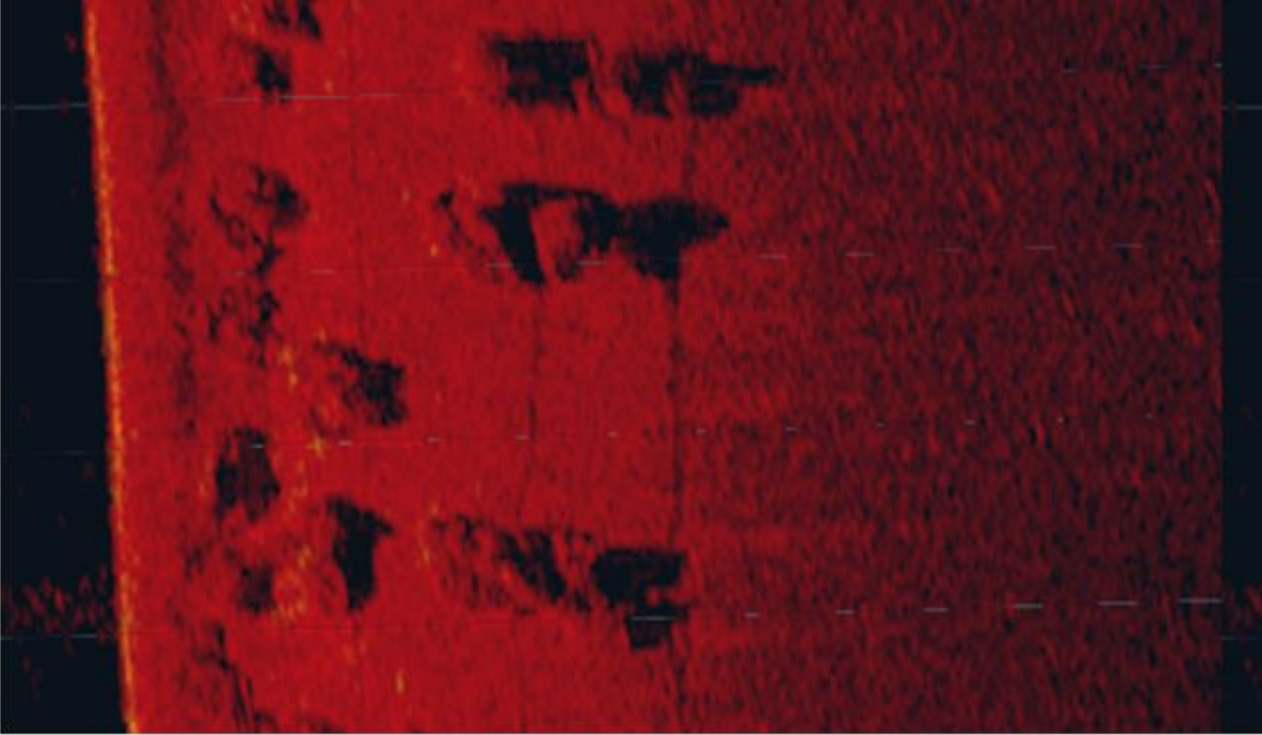
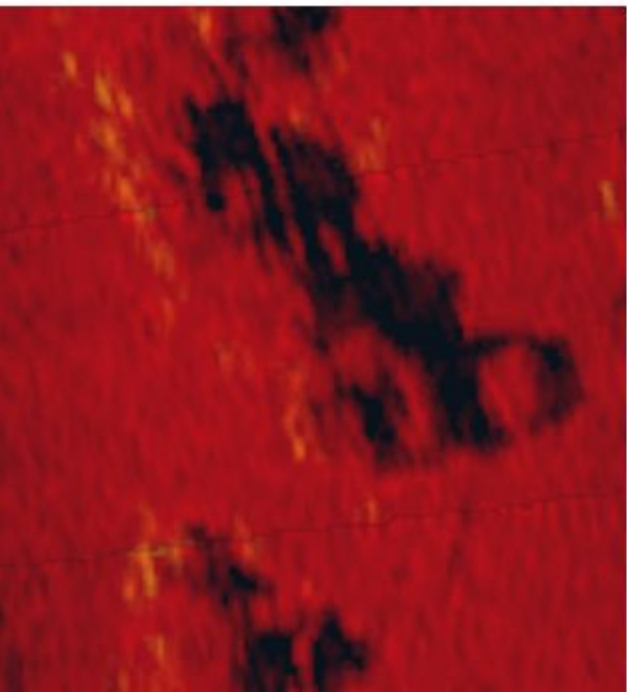
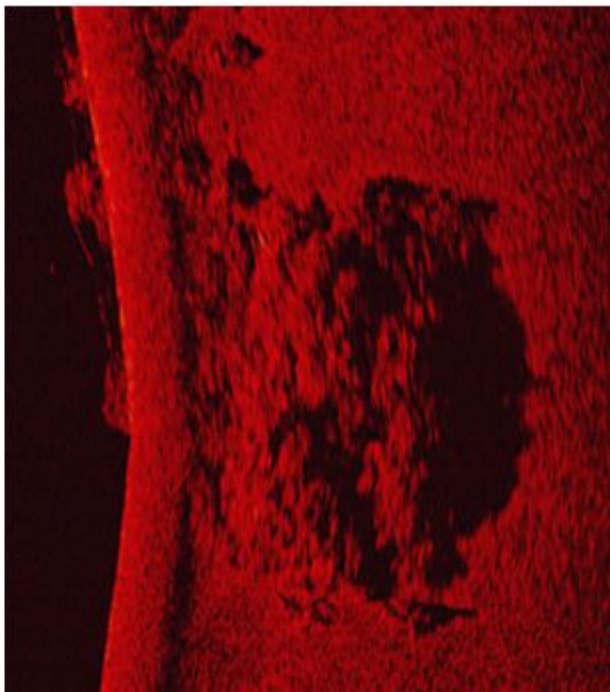
SONAR Findings

- High resolution Side Imaging SONAR shows at least 138 distinct tire clumps connected by lines in the vicinity of the Illahee pier.

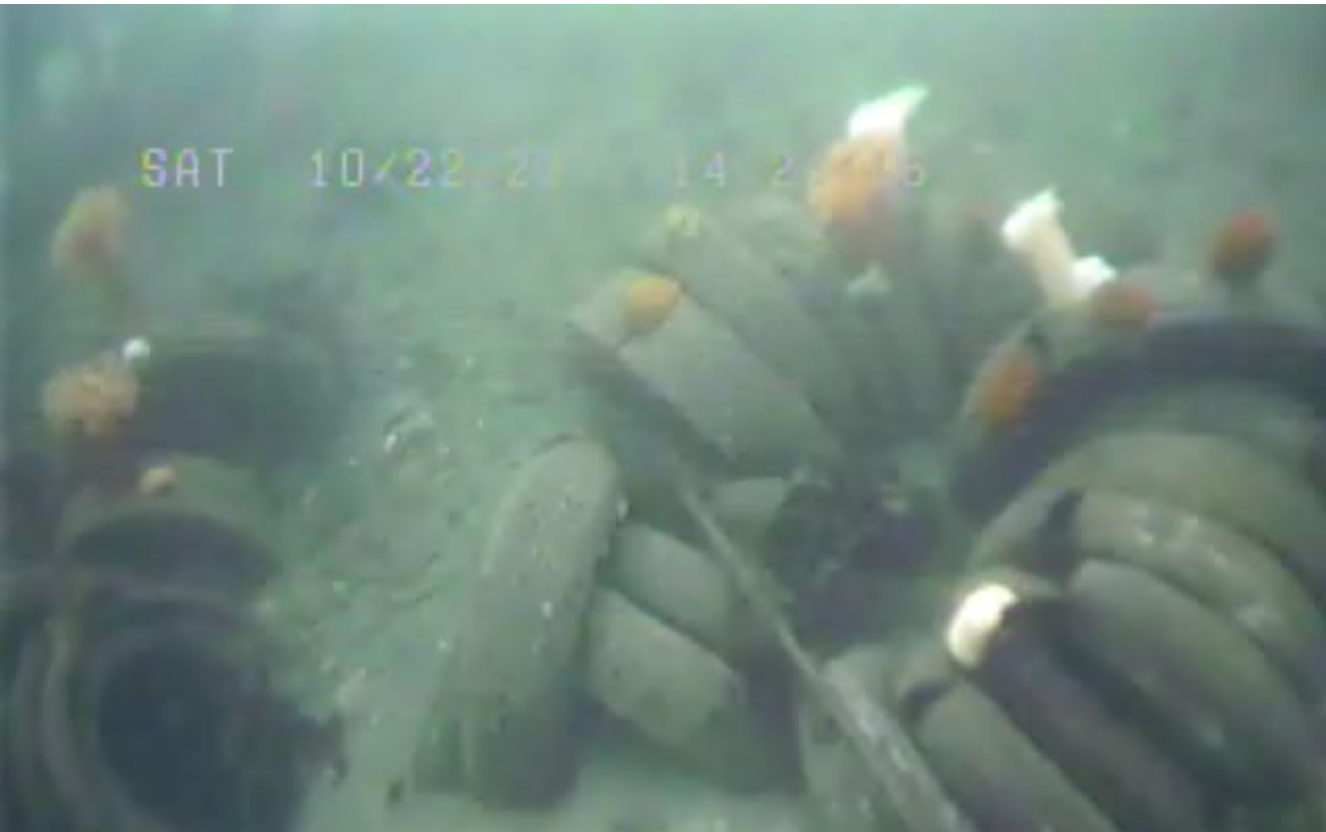
ROV Findings

- ROV Inspection confirmed SONAR imaging and provided the “per clump” estimated number of tires (between 12 and 20).
- This also shows that many of the clumps are at least partially buried and helps with recovery planning.
